## Restoring Abandoned ASGM Sites: A Solution to Environmental Degradation

Results of a Mission to Understand the Context of Abandoned ASGM Sites

### Artisanal and Small-Scale Gold Mining in Suriname

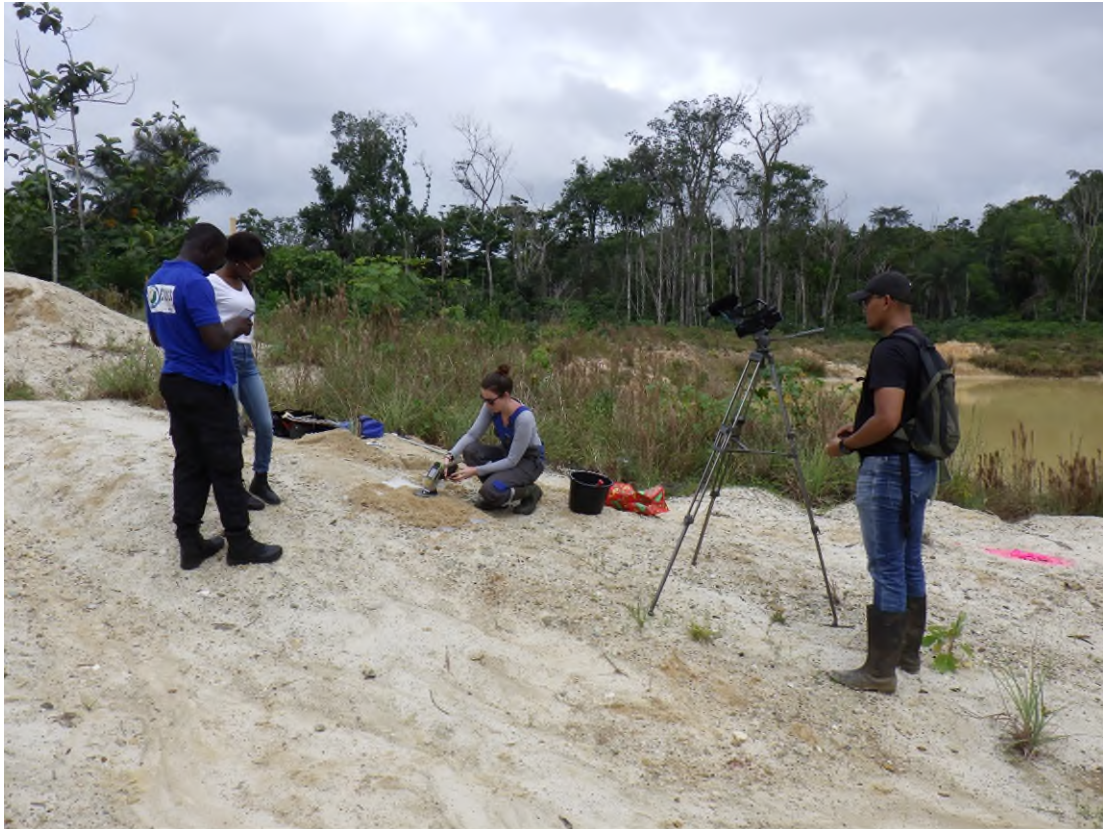
To investigate the site further and gather soil samples, manual boreholes were drilled to depths of up to 140 cm below ground level. The samples were described and digitally recorded, capturing vital information such as soil particle size, color, bulk density, soil compaction, soil pH, and heavy metal and nutrient content. A Handheld XRF device was employed for the analysis of heavy metals and nutrient content (Figure 5). Additionally, to validate the XRF results for heavy metal concentrations, selected soil and sediment samples were sent to the Eurofins Analytico laboratory in Barneveld, the Netherlands, for further analysis. Three surface water samples were also collected and analyzed in the field for pH and EC levels, while the laboratory analysis included heavy metal testing. The concentrations of these metals determine the need for potential measures to mitigate risks to both human health and the environment.

Extensive testing confirmed that all soil and sediment samples were deemed safe for use at the pilot site. Although slight elevations of mercury concentrations were detected in the sediment samples, these levels remained within permissible limits according to Dutch soil legislation. This means that the soil can be utilized for various purposes, including residential and agricultural areas. Notably, mercury concentrations in the water samples were found to be below the detection limit, ensuring the water's purity. However, laboratory results did reveal elevated values of copper and zinc concentrations in two samples taken from the pits, exceeding the allowable limits.

Figure 5 XRF measurements to determine the heavy metal and nutrient concentrations in the soil

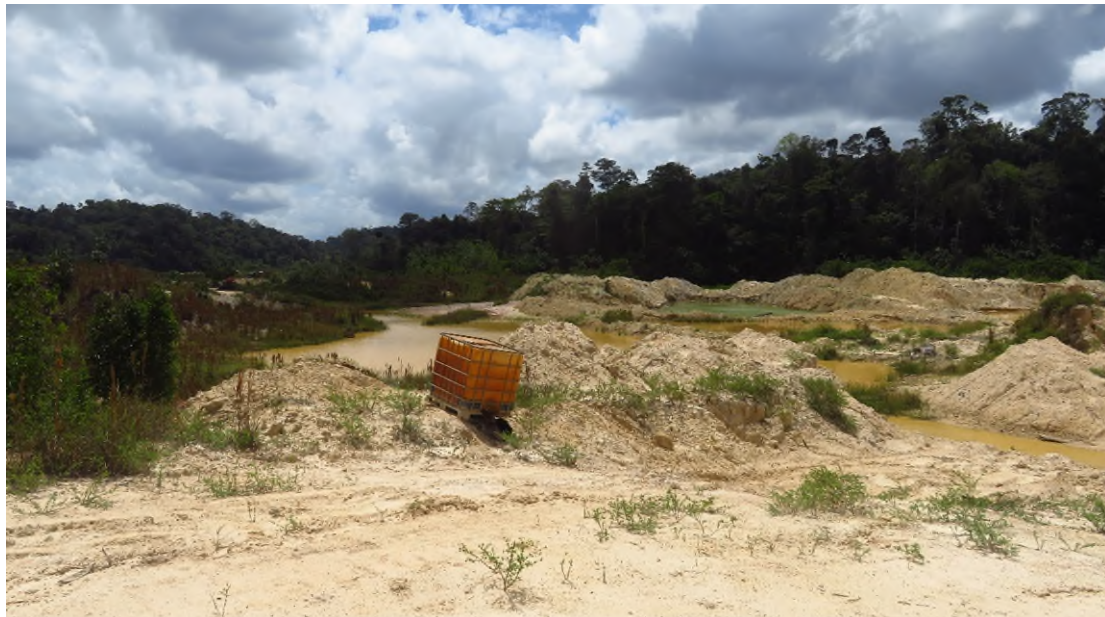
A preliminary design will be made for a more large-scale restoration of the pilot area (see Figure 6 for an impression photo of the larger site).

*Figure 6 Impression photo of the pilot site at Compagniekreek*

If additional funding becomes available, additional restoration activities can be implemented based on this preliminary design. The restoration activities will vary depending on the specific site and may include profiling the surface to achieve the desired elevation and safe slopes, and improving drainage and water management in the area.
